**Internal Review of MSHA's
Actions at the Upper Big Branch Mine-South
Performance Coal Company
Montcoal, Raleigh County, West Virginia**

U.S. Department of Labor
Mine Safety and Health Administration
Program Evaluation and Information Resources

March 6, 2012

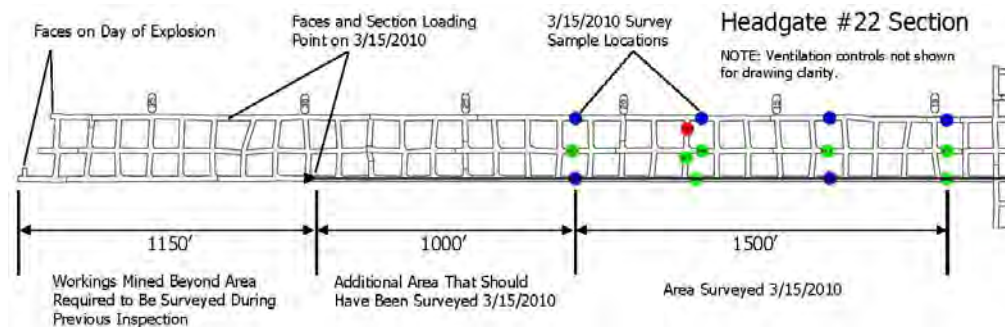
Figure 12 - Headgate #22 Section showing faces at time of explosion relevant to face and belt locations during March 15, 2010, rock dust survey.

MSHA procedures directed inspectors to make visual observations of rock dust application adequacy when inspecting sections between surveys. However, accurate visual estimation of mine dust IC was not reliable. In January 2010, District 4 managers provided additional guidance for determining compliance with rock dusting requirements on working sections when they instructed inspectors to collect spot samples of mine dust inby section loading points during each regular inspection. During interviews, District 4 managers stated that these instructions were intended to stress the requirement to rock dust within 40 feet of working faces, as well as to improve compliance with clean-up programs. An inspector collected one spot sample in accordance with this guidance at UBB, which was compliant, on March 17, 2010, on 4 Section (Barrier Section).

Active sections not surveyed to within 50 feet of the loading point. MSHA procedures direct inspectors to conduct a rock dust survey to within 50 feet outby the section dumping point on each advancing active working section. However, these procedures did not direct inspectors to document the location of the section loading point when conducting rock dust surveys. Thus, supervisors could not verify that inspectors sampled to within 50 feet of the loading point. Failure to follow this directive resulted in two un-surveyed zones within the explosion area.

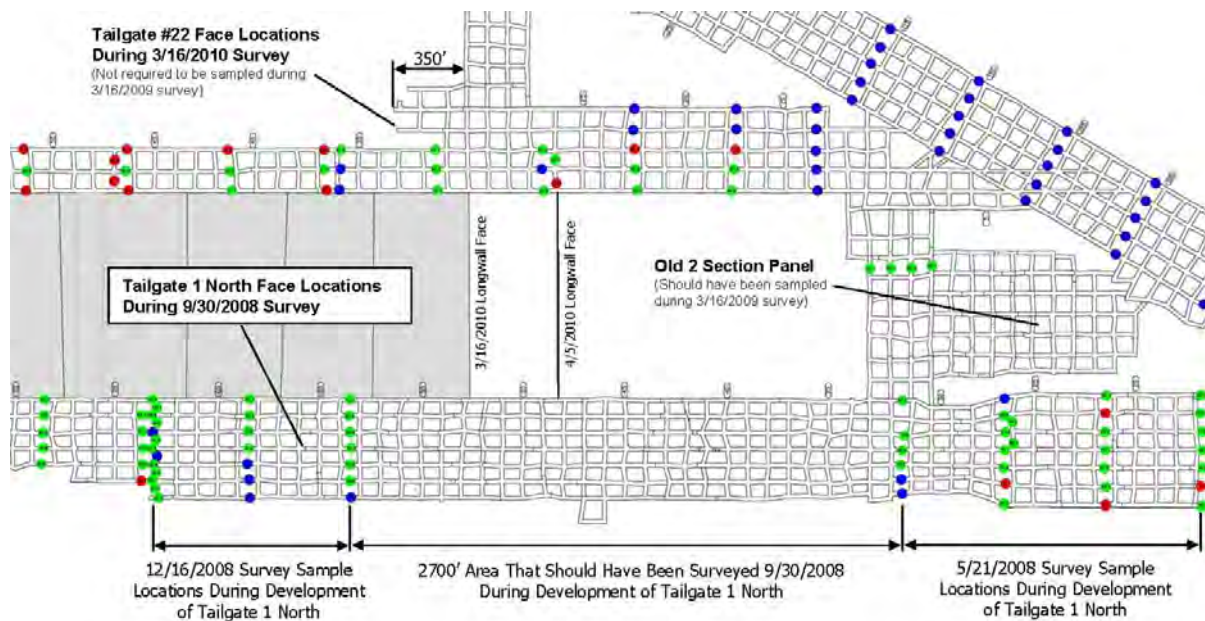
Figure 13 - Survey samples collected near the 1 North Longwall Panel.

In another case, an inspector uploaded data for a September 30, 2008, rock dust survey during development of Tailgate 1 North. However, he did not provide a zero point that precisely identified the sampling area so it could be located on the mine map. The inspector listed two rows of samples rather than the five rows of samples needed to survey the area mined since the last inspection (see Figure 13). He also listed all of the survey sample locations as being too wet to sample. With no way to map these wet sample locations, subsequent inspectors could not accurately determine where to begin the next survey or to collect samples if the area dried out.

On December 16, 2008, another inspector started the next rock dust survey in Tailgate 1 North at Crosscut 58, which would have corresponded to the section loading point at the time of the previous survey. However, deficiencies in documentation for the September 30 survey and lack of sampling at previously wet locations resulted in a 2,700-foot long area where MSHA did not collect rock dust samples. At the time of the explosion, this unsampled area extended from 1,000 feet inby to 1,700 feet outby the longwall face.

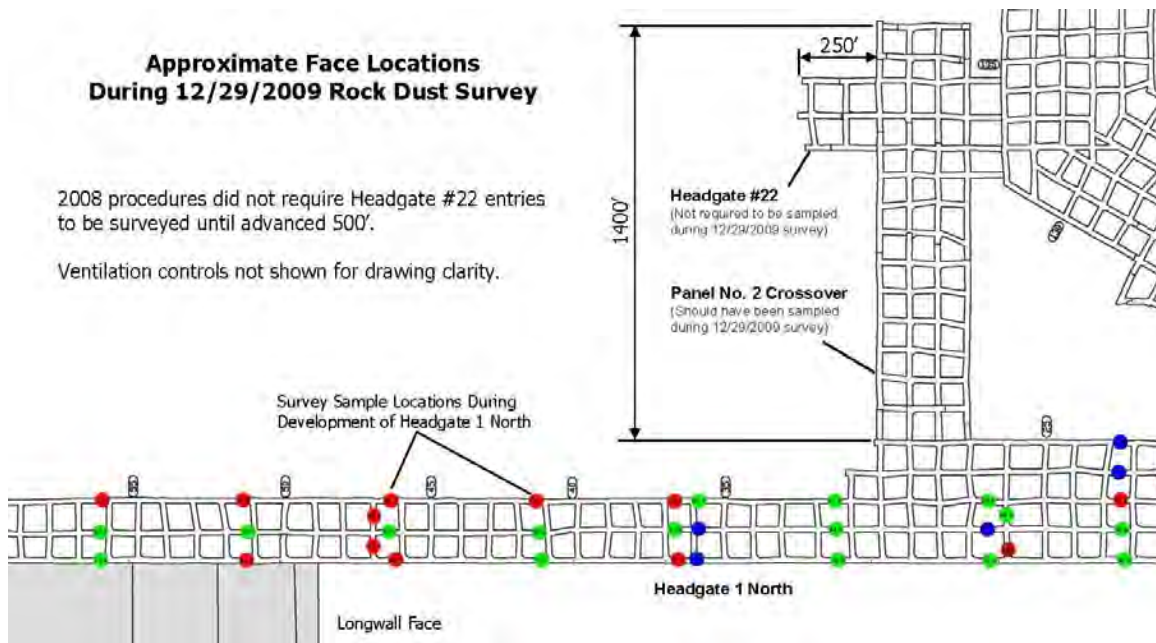
Figure 14 - Face locations at time of December 29, 2009, rock dust survey for MMU 029-0.

After MSHA implemented the revised inspection procedures in 2008, some inspectors continued to sample only the set of entries being mined at the time of the survey. On December 29, 2009, an inspector documented conducting a survey for 1 Section in which he did not collect any samples, reporting a single location as "No Sample." The inspector commented on the Rock Dust Sample Submission Form, "The mine operator has mined less than 500 feet since last survey area." However, since the prior rock dust survey for 1 Section, it had mined the last 500 feet of Headgate 1 North (Bandytown Shaft bottom area), the entire 1,400-foot long Panel No. 2 Crossover, and the first 250 feet of Headgate #22 (refer to the Figure 14). The April 5 explosion propagated through the two latter areas.

During interviews, the inspector stated that he did not conduct a rock dust survey in Headgate #22 because the distance from the mouth of the section to the tailpiece was less than 500 feet. While MSHA procedures did not direct him to sample Headgate #22 entries at that time, he did not consider surveying the two areas from which the MMU was removed. He also stated that he primarily learned how to conduct surveys by traveling with other inspectors. The only National Mine Health and Safety Academy training he remembered was the instruction to take samples every 500 feet and how to collect band samples. This further demonstrated that at least some inspectors continued to follow superseded procedures, passed on by more experienced inspectors and supervisors, regardless of training to the contrary. As a result, MSHA did not collect survey samples before the explosion in the Bandytown Shaft bottom area and the Panel No. 2 Crossover.

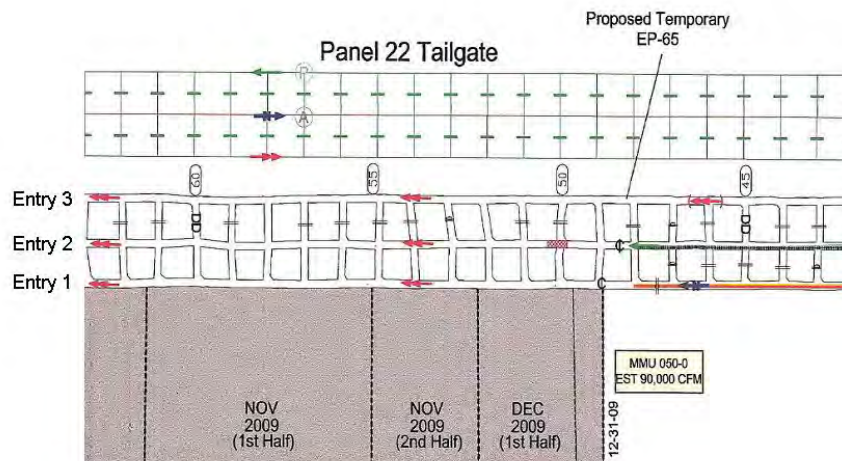
Figure 18 - Portion of ventilation plan supplement approved January 22, 2010, showing EP-65

In the ventilation plan supplement approved January 22, 2010, a temporary evaluation point (EP-65) was added (See Figure 18) to account for the return air split from Headgate #22 section which entered the worked out area. The Operator specified that the EP would move outby with the 1 North Longwall face until it reached the regulator at crosscut 31. Once the longwall face reached crosscut 31, the EP would become permanently established at the regulator installed in this crosscut. This evaluation point was critical in determining the effectiveness of ventilation on the headgate side of the worked out area. However, there was no record of an air reading being taken at this EP by either MSHA inspectors or UBB examiners.

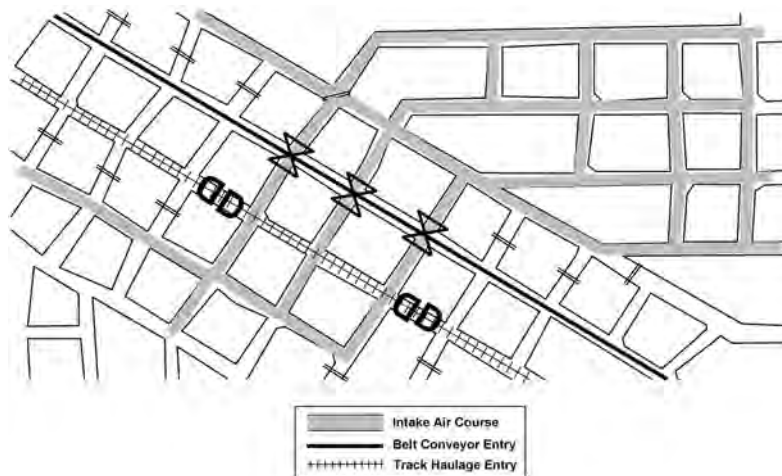
Figure 19 - Depiction of actual installation of equipment doors in the North Glory Mains

Figure 19 shows one such installation in the main track haulage road of the North Glory Mains. At the time of the explosion, miners accessed the 1 North Longwall and two development sections (Headgate #22 and Tailgate #22) using this roadway. Coal was transported in the adjacent belt conveyor entry. The two entries containing the track and belt conveyor were ventilated by a common air split along much of their length. However, where a separate intake air course crossed the belt conveyor air course, the Operator installed two sets of equipment doors. Miners drove track equipment through one set of doors, into the separate intake air split, then through a second set of doors, back into the air course containing the belt conveyor system. The belt conveyor air course was reduced from two entries to one where it crossed a set of overcasts that permitted the two air splits to cross without mixing. These air courses could not mix at this location since they isolated primary and alternate escapeways and the intake split (shown in gray) that ventilated the working sections.

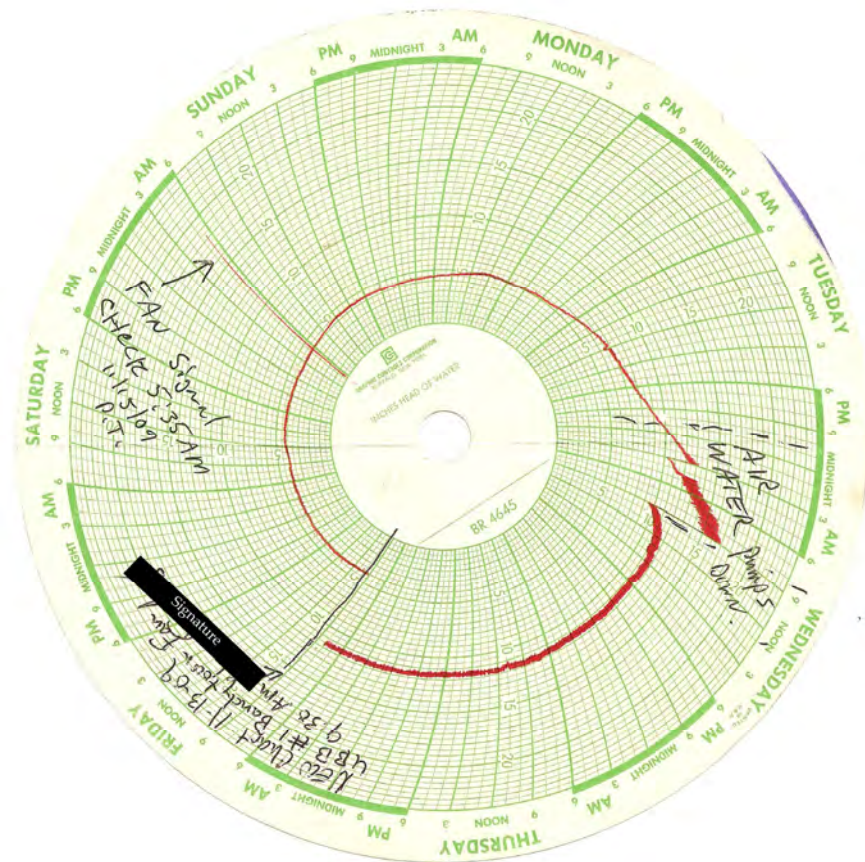
Figure 22 - Bandytown Fan Chart from November 2009

On November 13, 2009, the fan pressure recorded at the Bandytown Fan was approximately -4.0 inches of water.⁷³ On Monday, November 16, the fan pressure began to gradually increase. By Wednesday, November 18, a fan pressure of -17.0 inches of water was recorded. During this time period, a handwritten notation on the Bandytown Fan pressure chart indicated “pumps down.” The fan pressure chart is shown in Figure 22.

On November 19, 2009, a District 4 ventilation specialist examined the longwall headgate entries and observed an accumulation of water 12 to 15 inches in depth in the No. 3 entry extending a distance of 300 feet from crosscut 55 to 58. At that time according to production reports, the longwall face was at crosscut 54 on Headgate 1 North. The specialist issued a section 104(a) citation (No. 6612944) for this violation of 30 CFR 75.364(b)(2). During his interview with the Internal Review team, the specialist stated that the water level was not increasing. At that time, the fan pressure on the Bandytown Fan chart was reduced to approximately -11.5 inches of water as a result of pumping.
