**Internal Review of MSHA's
Actions at the Upper Big Branch Mine-South
Performance Coal Company
Montcoal, Raleigh County, West Virginia**

U.S. Department of Labor
Mine Safety and Health Administration
Program Evaluation and Information Resources

March 6, 2012

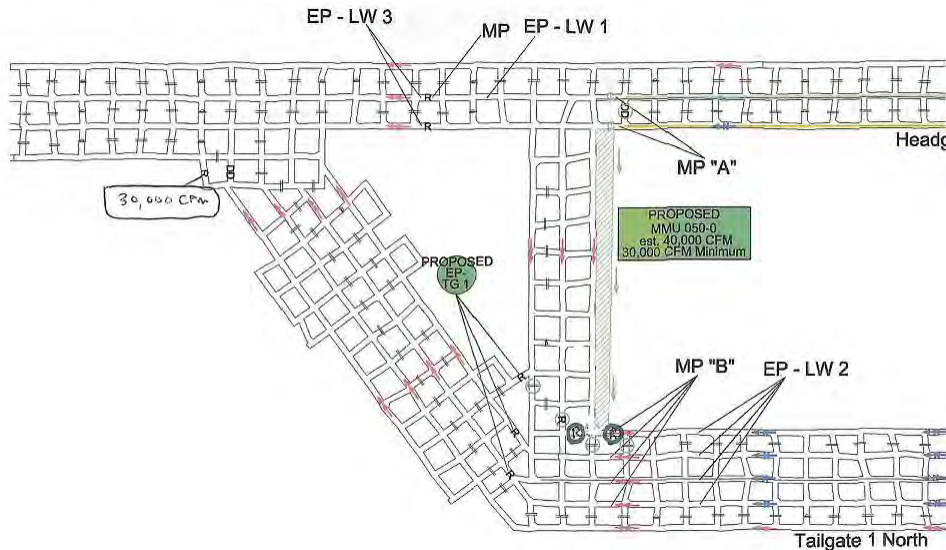
Figure 15 - Original evaluation point locations approved September 11, 2009, in mine ventilation plan

Before the 1 North Longwall started production, the Operator submitted a method to evaluate the bleeder system for the longwall panel in a ventilation plan supplement approved by the District 4 Manager on August 6, 2009. The supplement was later incorporated into a new base ventilation plan approved on September 11, 2009. The approval included a mine map with the evaluation points (EPs) identified. A section of that map is shown in Figure 15.

Inlet and outlet evaluation points established by the Operator for the system were identified in the approved base ventilation plan. The No. 1 entry of the 1 North Longwall tailgate and the No. 3 entry of the longwall headgate were maintained as isolated development section returns. Air flow into the worked-out area from these splits was limited to leakage. Therefore the initial evaluation points established did not need to account for airflow in these air courses.

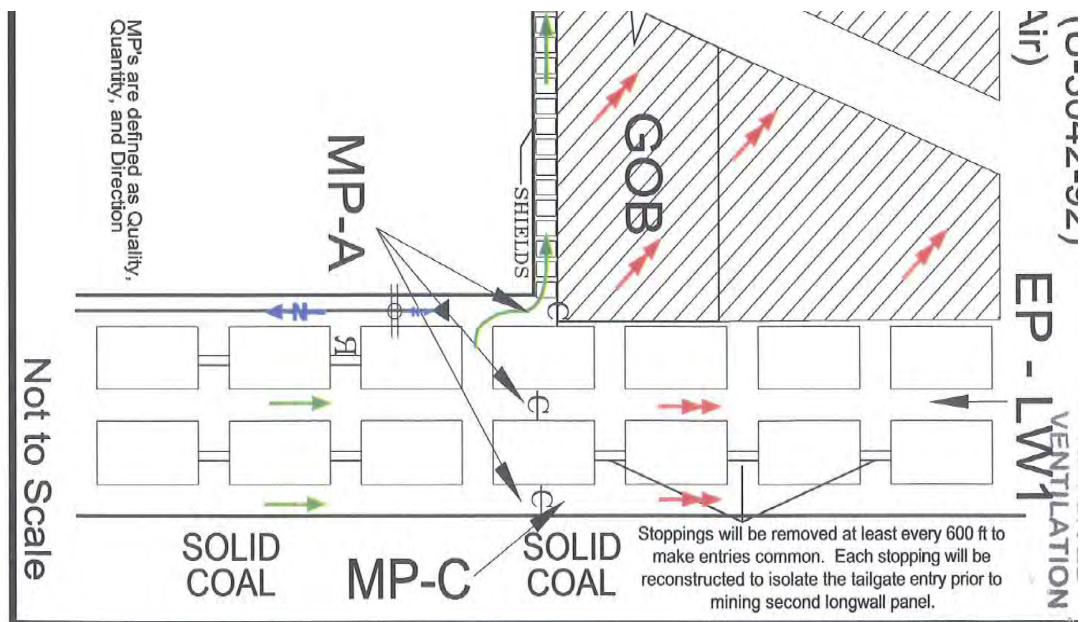
Figure 16 - Portion of drawing from ventilation plan supplement approved December 18, 2009

The Operator submitted a ventilation plan supplement on December 14, 2009, that provided for stoppings to be removed at intervals of at least every 600 feet between the No. 3 and No. 2 longwall Headgate entries. As a result, the No. 3 and No. 2 longwall headgate entries became common, with the No. 3 entry becoming part of the worked-out area. The supplement specified these stoppings would be reconstructed to isolate the future tailgate entry prior to mining the adjacent longwall panel. The supplement also established an additional measuring point where intake air entered the worked out area in the No. 3 entry of the headgate, identified as MP-C in Figure 16.

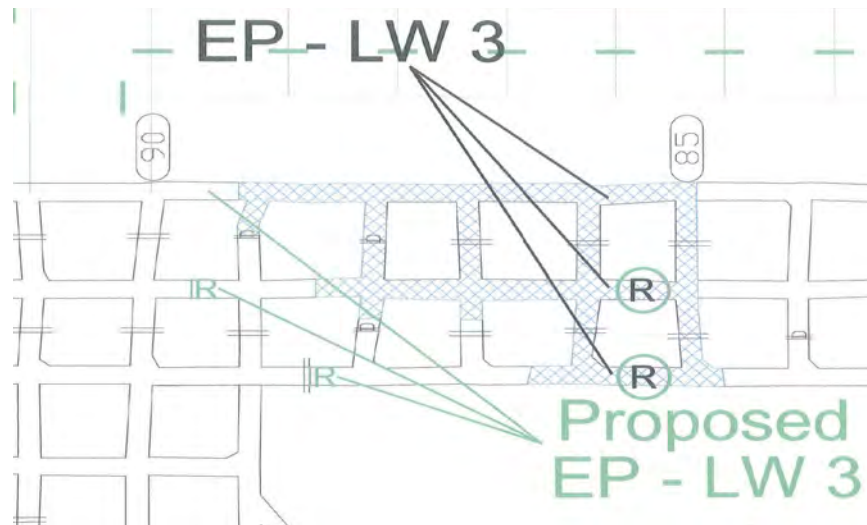
Figure 17 - Drawing of evaluation points from supplement approved February 22, 2010

In addition, an evaluation point was established in the No. 3 entry at EP-LW3 behind the longwall panel. This EP was needed since air was exiting the worked-out area at this location, and would have been necessary to properly evaluate the bleeder system. In a ventilation plan supplement approved on February 22, 2010, this EP was relocated from crosscut 85 to crosscut 90 due to a water accumulation. (See Figure 17.)

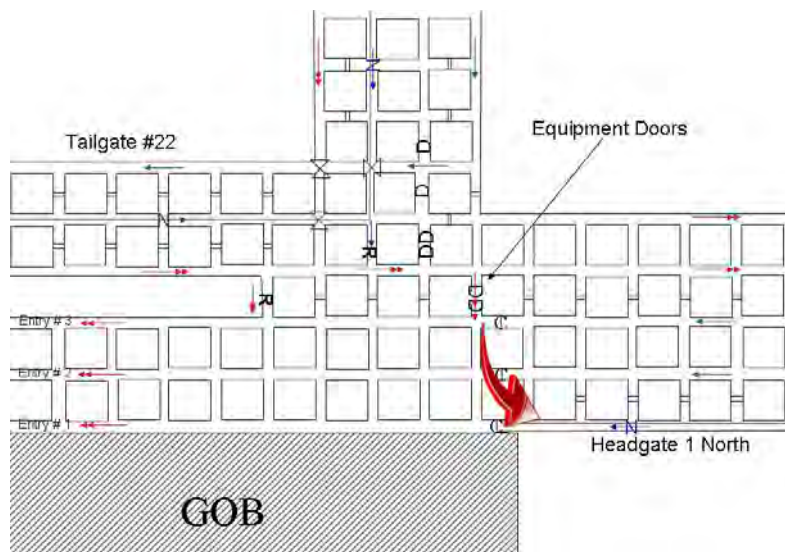
Figure 21 - Latest Headgate Ventilation Design

District 4 personnel indicated during interviews that safety standards did not prohibit the use of equipment doors in this manner. However, 30 CFR 75.333(d)(1) does not provide guidance to operators or inspectors regarding the evaluation of equipment door installations, and MSHA policy has never been developed to address enforcement of this standard.

The MSHA Accident Investigation team found that open equipment doors at key locations would not have caused a dramatic decrease in the intake air quantity for the 1 North Longwall. However, some reductions on the Headgate #22 and Tailgate #22 development sections were possible when equipment doors installed on the longwall intake were opened. The Accident Investigation team also found that return air from the development sections could be routed to the longwall face when equipment doors between the No. 3 entry of the longwall headgate and the No. 1 entry of Tailgate #22 were left open (see Figure 21). The Accident Investigation team determined through interviews with miners that there was at least one occasion when this occurred.

Conclusion: Mine design and plans incorporating equipment doors in critical areas often create a ventilation system too fragile to maintain an acceptable degree of safety for miners. Currently, regulations address the use of equipment doors to separate air courses in lieu of stoppings. However, the proper installation, operation, and maintenance of equipment doors are critical for maintaining a safe and effectively ventilated mine.
